UNITED STATES ENVIRONMENTAL PROTECTION AGENCY
REGION 5

SUBJECT: Plant Inspection
Metropolitan Wastewater Treatment Plant
2400 Childs Road
St. Paul, Minnesota

Inspection Date: August 19, 1997

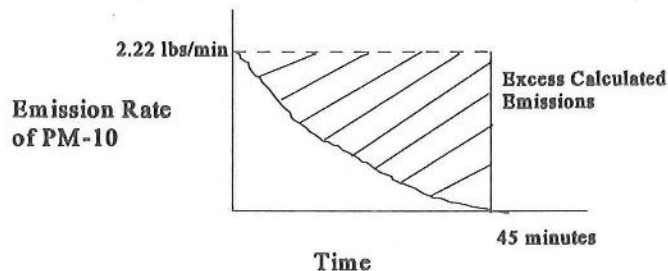
When the damper opens and feed stops, the burnout process takes about 45 minutes, as a conservative estimate; most likely it takes about 30 minutes. Mr. Brown pointed out that the estimate made of stack emissions when burnout occurs assumes that throughout the process, the amount of PM-10 is steadily released at 2.22 lb/min. In reality, however, the emission rate during

burnout actually decreases. The following diagram depicts this difference in calculation.

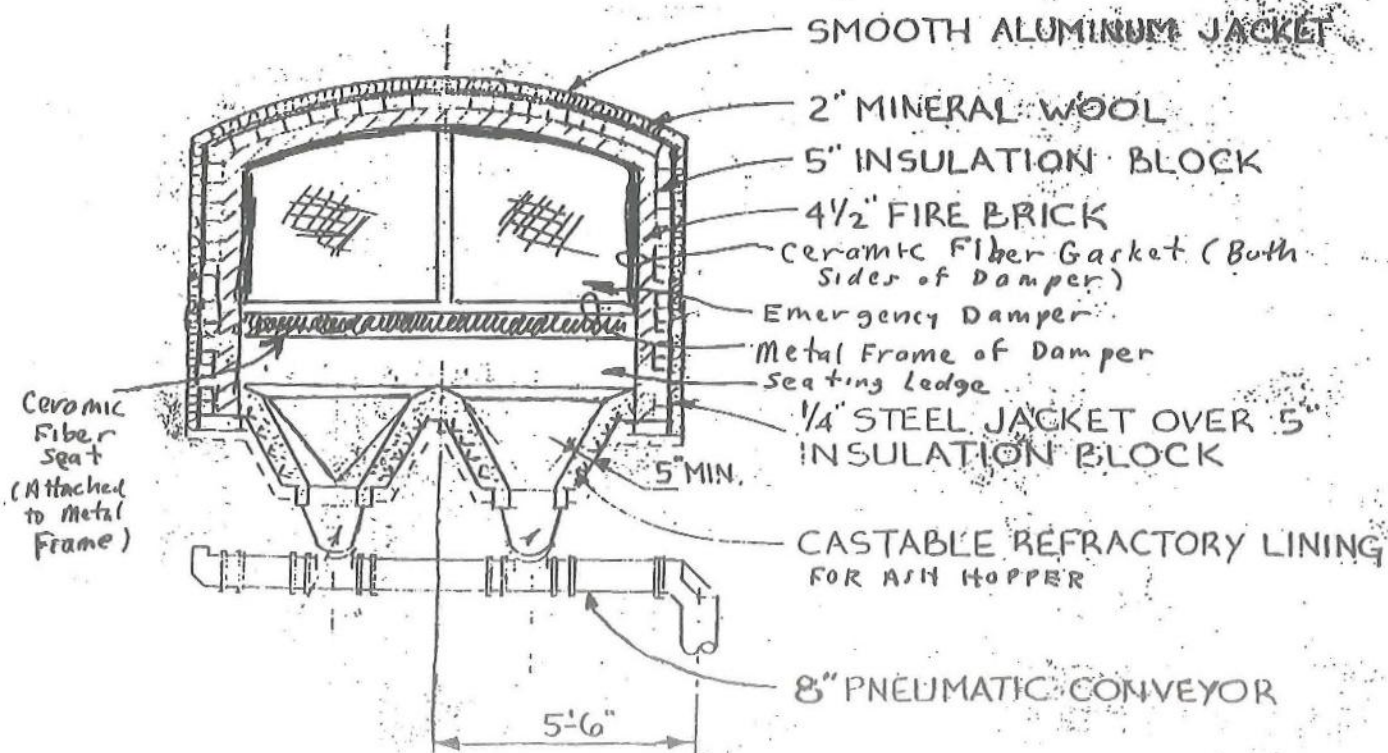
FIGURE 3
VIEW OF EMERGENCY BREACH/DAMPER FROM INSIDE HEARTH

MC has taken measures to improve the damper seal. The damper is a metal guillotine. When closed, the damper is in contact with a brick ledge, which does not act as a very good seal. In 1996 MC installed a ceramic fiber seat made of crushable material and added a gasket on the top and sides of the damper. These improvements however did not prove effective; the fiber tore off as the guillotine was lowered and raised. The damper still does not seal tightly.

We started by looking at incinerator 9 which was down for annual maintenance at the time. We looked inside a hearth and could see the rabble arms and then later actually climbed into hearth 0 of incinerator 9. Mr. Brown showed us the damper system, pointing out the fiber-like material that they put on the brick ledge and around the top and sides in order to form a tighter seal around the damper. Because the material was being torn off the top and sides as the damper raised and lowered, they also had installed metal to hopefully support the fiber. This type of seal did not seem to improve leakage. Pass the damper, we walked further into the bypass tunnel and peered up the emergency stack. Mr. Brown then took us to the other side of the incinerator which led to the control train. We saw the 4 divided sections that vented to the quad cyclone. There were large quantities of dust inside and around the incinerator and brick ducts.

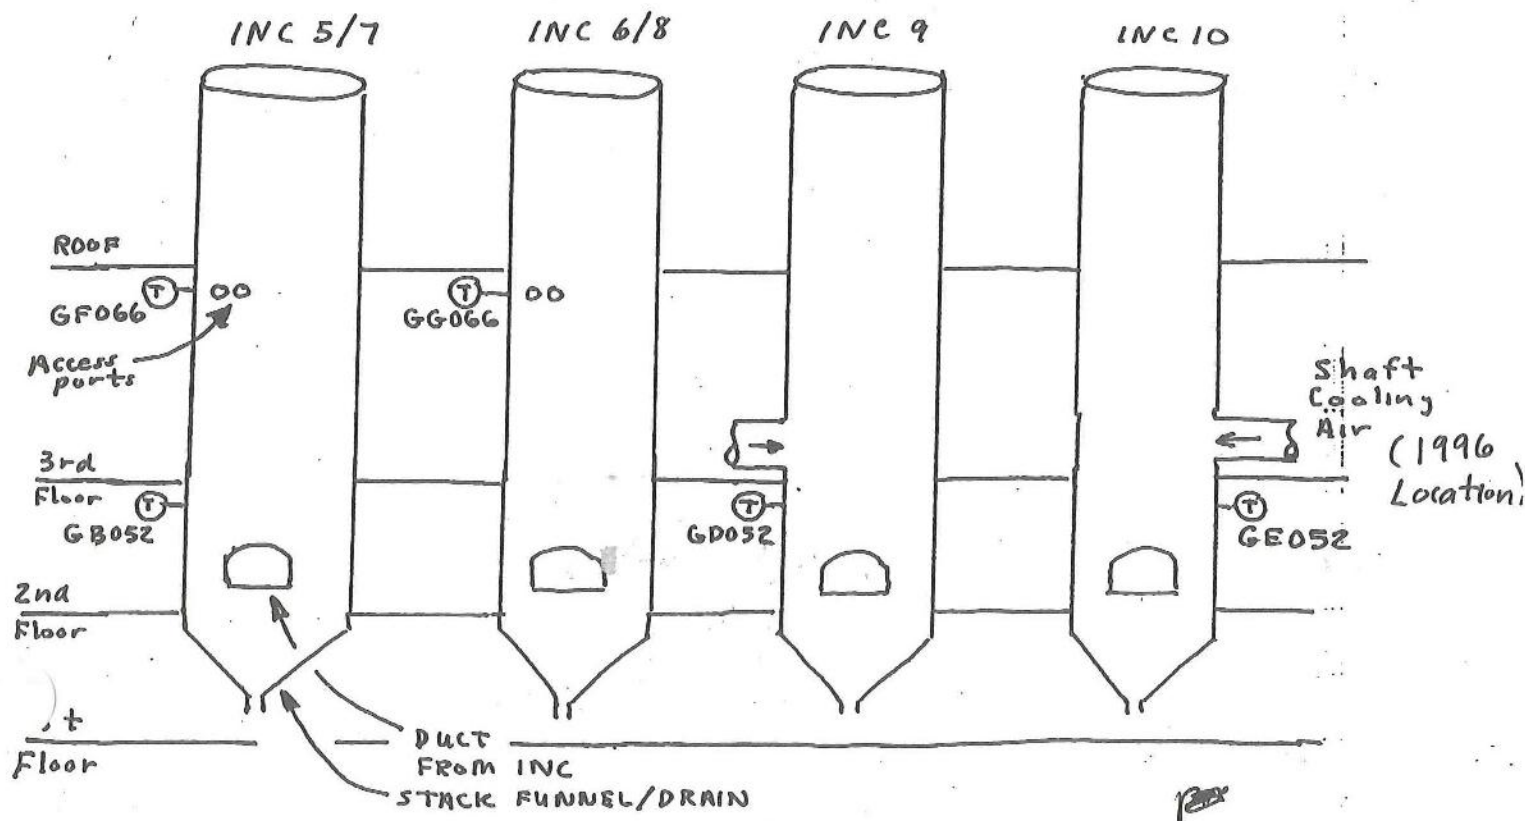
FIGURE 4
THERMOCOUPLES FOR MONITORING
OF RELIEF STACK TEMPERATURES

GB 052 T T - 5/7 Stack, top of 2nd floor
 GF 066 T T - 5/7 Stack, below roof line
 GG 066 T T - 6/8 Stack, below roof line
 GD 052 T T - Inc 9 Stack, top of 2nd floor
 GE 052 T T - Inc 10 Stack, top of 2nd floor

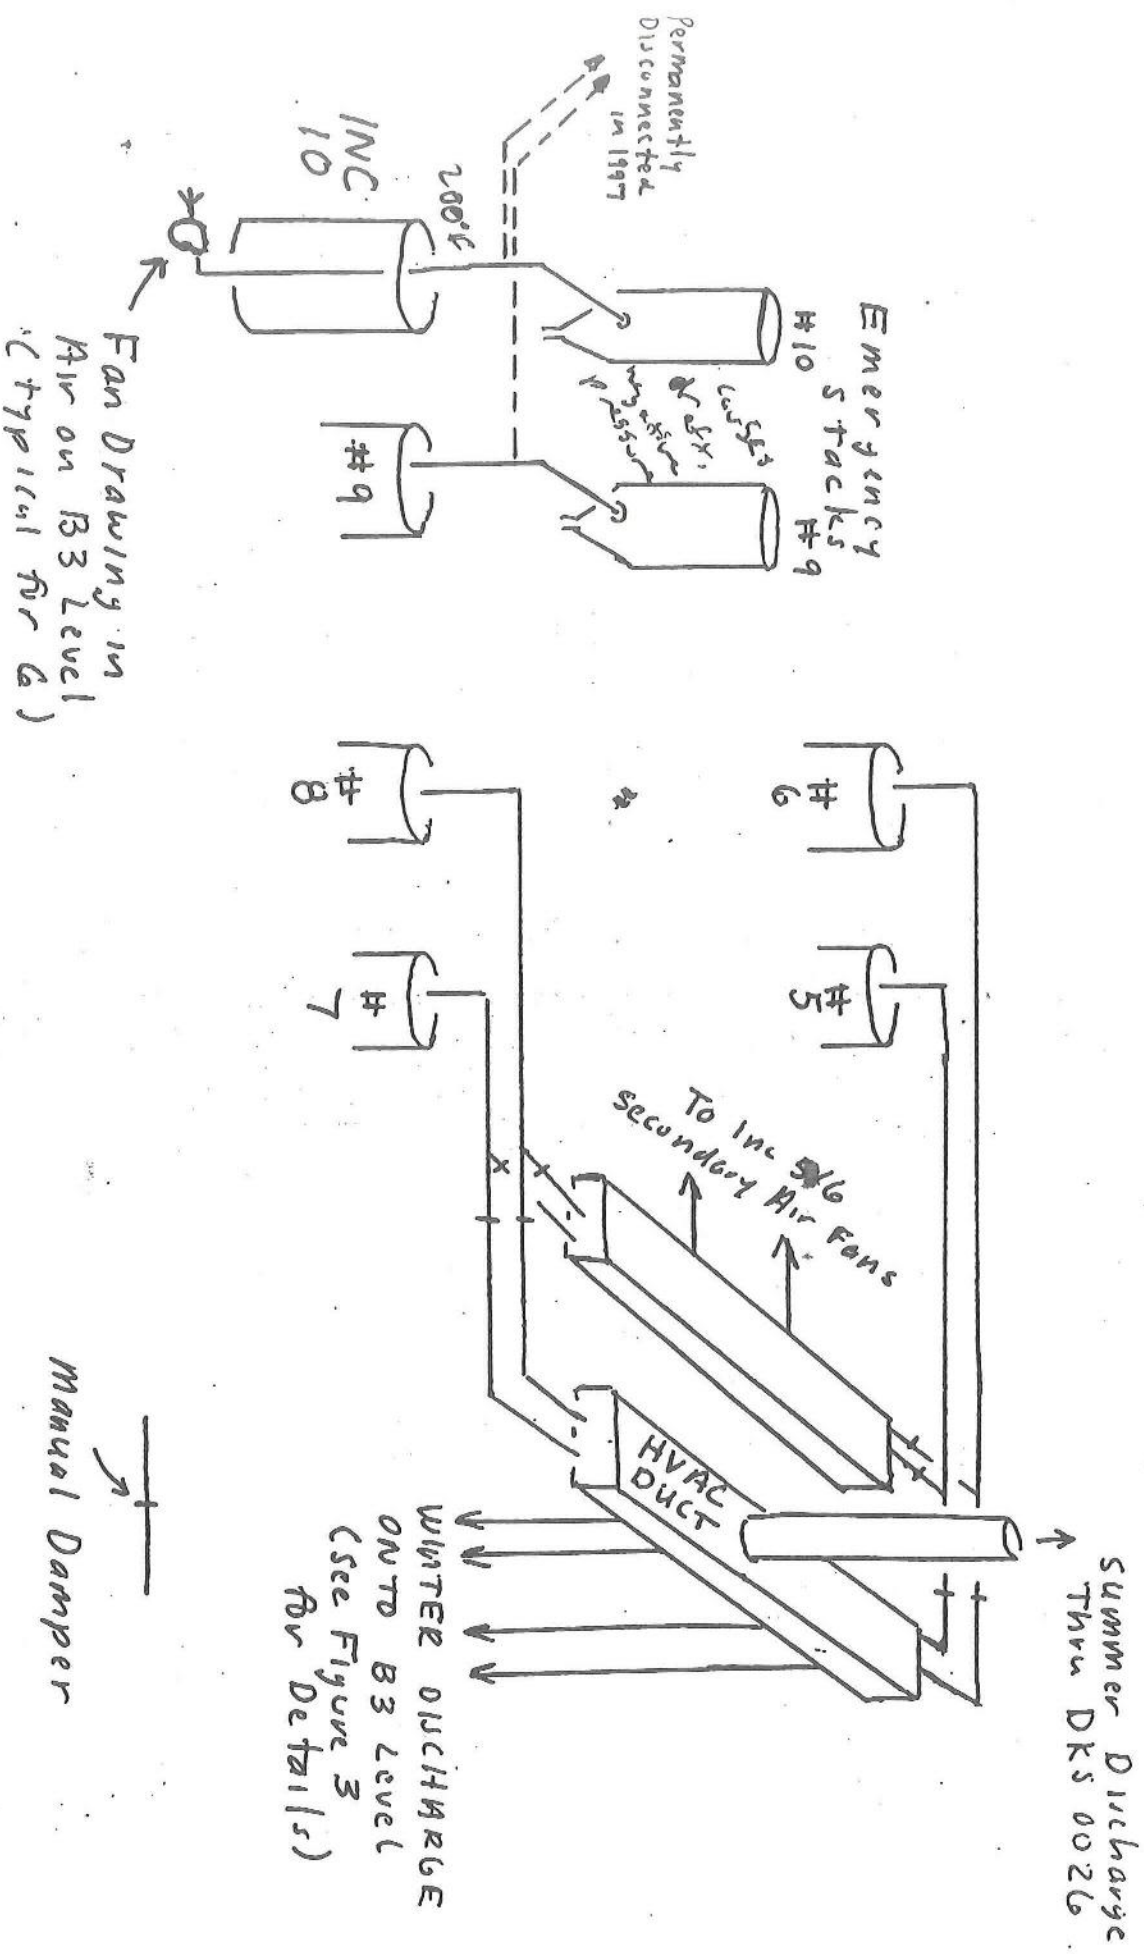
Shaft Cooling Air Routing - December 1996

In all incinerators, the hot air that flows through the center shaft of the incinerator and the rabble arms was vented to either the building's HVAC system (incinerators 5-9) or their own emergency stack (incinerators 9 and 10). The staff speculates that the hot air from incinerators 9 and 10 being emitted into the emergency stack was causing additional draft, therefore they decided to reroute the hot air from incinerators 9 and 10 to the outside. In early 1997, they disconnected the lines from incinerator 9 and 10, resulting in a decrease in damper leakage. (See page 16 of attachment 1)

above in the pre-inspection discussion, hot air that comes from the center shafts of incinerators 9 and 10 is now vented to the outside rather than the emergency stack. Mr Brown pointed out the location of the old lines and the duct work of the new lines. In early 1997, MC spent about \$15,000 closing off and building ductwork for this project, which has reduced leakage by about 60%. Wind, however, at the height of the stack is still a problem, inducing drafts inside the emergency stack. Presently there is a wind station so operators can monitor wind speed; in addition they can also measure hearth and stack draft.

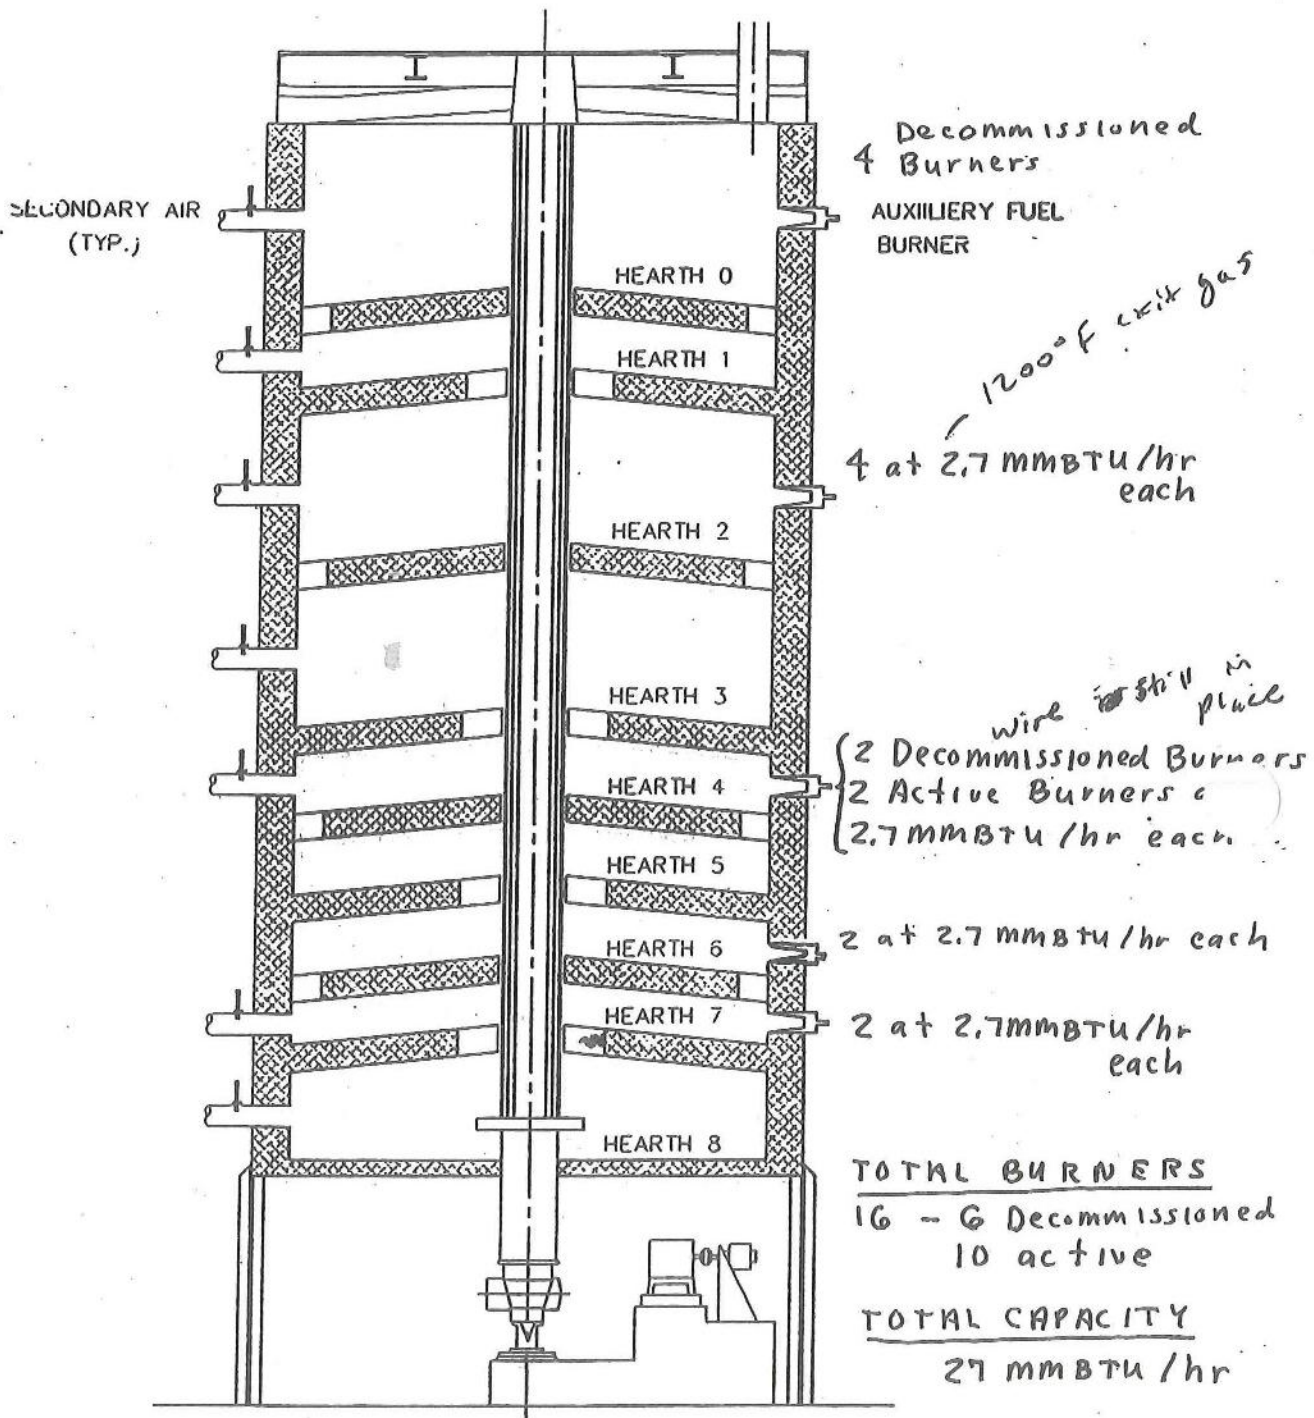
INCINERATOR #8

Mr. Brown discussed the changes made to incinerator 8. Of the 16 burners, only 10 are active; 6 have had the wires removed. Two burners have been moved from hearth 0 to hearth 2; two burners had been added to hearth 4 and are presently still wired but locked up. The total maximum capacity of incinerator of 8 is 27 mmbtu/hr. The average operating condition is 7 mmbtu/hr and will at the highest be 15 mmbtu/hr during start up. (See page 18 of attachment 1). After these changes have been made, the maximum capacity has decreased 2 mmbtu/hr.

avg. 7 mmbtu/hr
 heating up
 16-17
 is
